## EN 124-1 Pit Cover Testing

### 36" x 24" Pit Cover

JID 19-00074

**JID 19-00074 36 x 24 TEST REPORT**

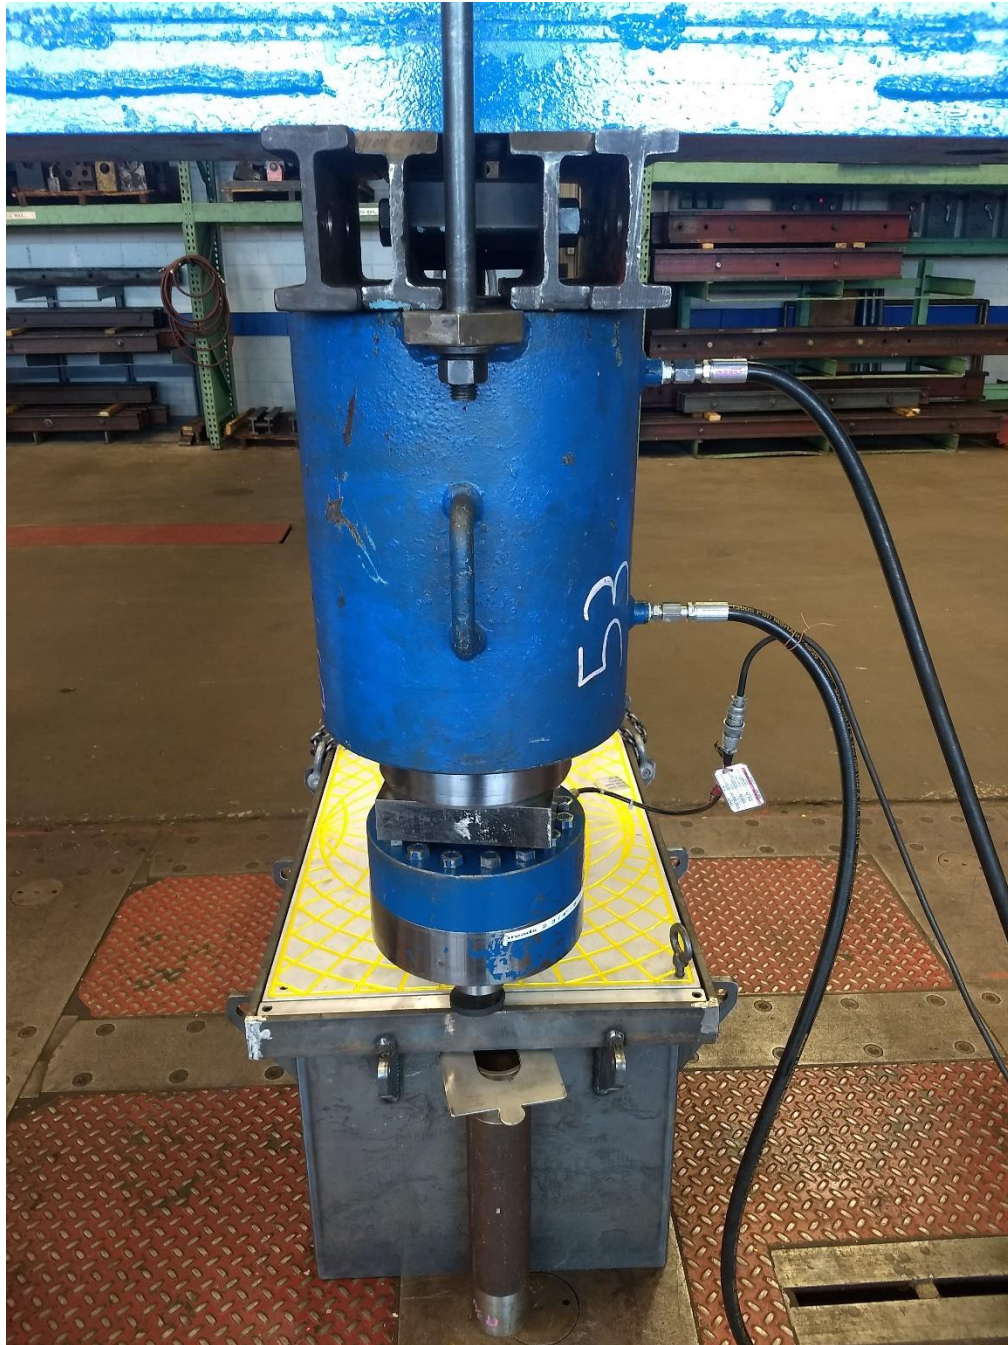
**Photograph 1 Tilt Testing Setup**

8.4.5 Compatibility of seatings. Perform tilt test per Annex D.

Apply load from 0 to 50 kN (11,240 lbs) at 1-5 kN/s (225 – 1124 lbs/sec) 3 times in center of each side with 75 mm dia test block and 10 mm thick rubber sheet. Record tilting height on opposite side. Temperature must be between 59 and 95 deg F.

The following test method is intended to demonstrate compliance with EN 124-1:2015. Photograph 1 and Photograph 2 show the test setup.

8.4.5 Compatibility of Seatings. The tilt test demonstrated a maximum tilting height of 1.4 mm. This meets the requirement of  $0.5 * \text{depth of insertion}$  or 25 mm. It should be noted that the face seal was not in place for this test.

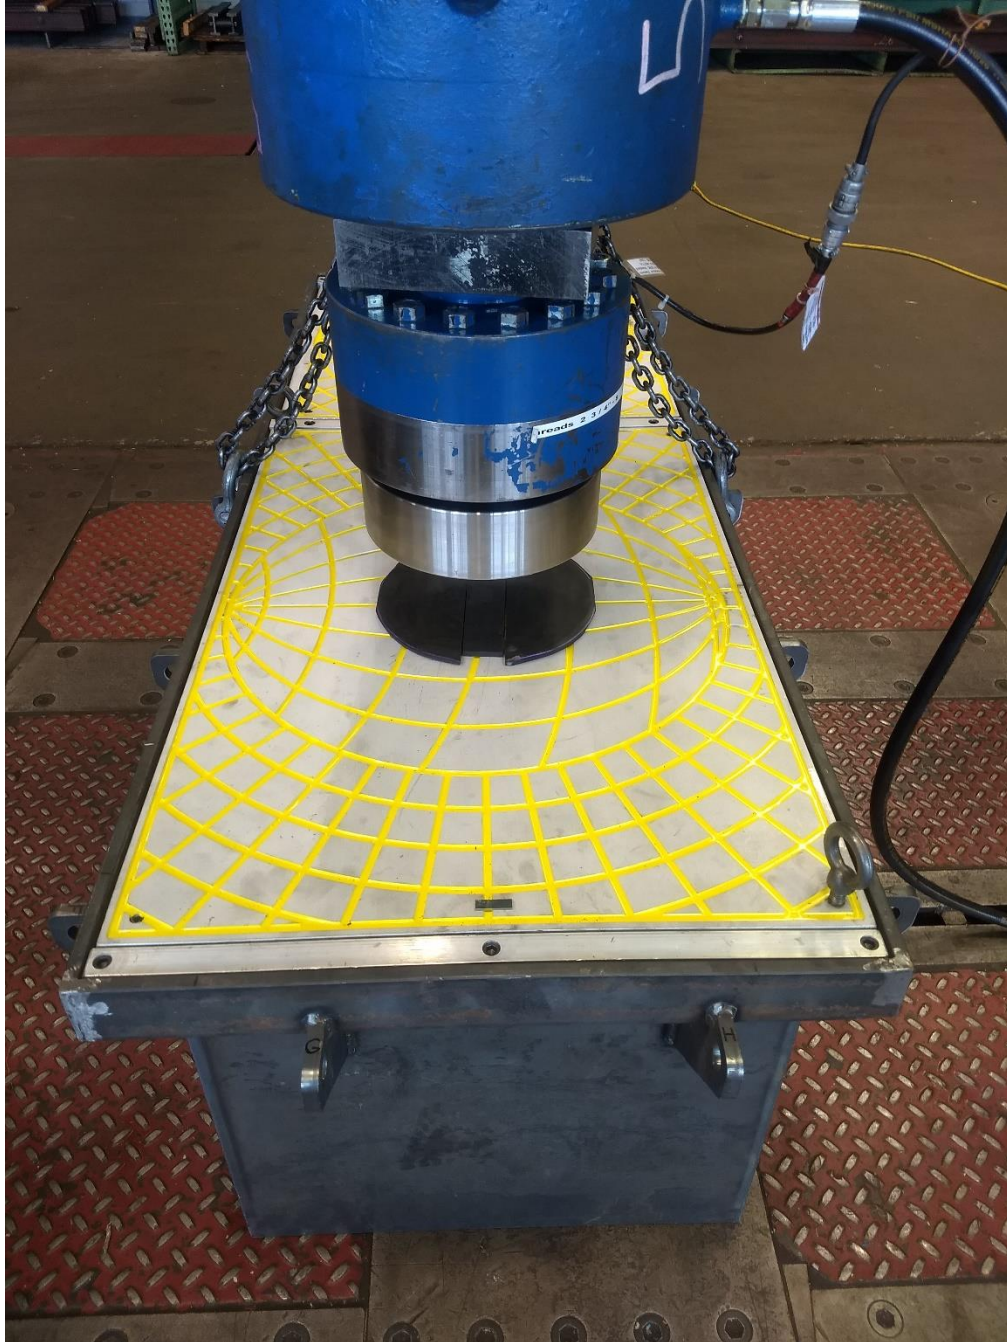
**Photograph 2 Load Test Setup**

8.2 Permanent set. Perform permanent set test per Annex A.

Apply 600 kN (134,885 lbs) vertical load 5 times at a rate of 1-5 kN/s. Measure the permanent set to an accuracy of 0.1 mm (.004”).

8.3 Load bearing capacity. Perform load test per Annex B.

Apply 900 kN (202,328 lbs) vertical load.

8.2 After the permanent set test the cover permanent set was measured to be 0.61 mm. This meets the requirement of  $< 1.1$  mm (based on the measured clear opening).

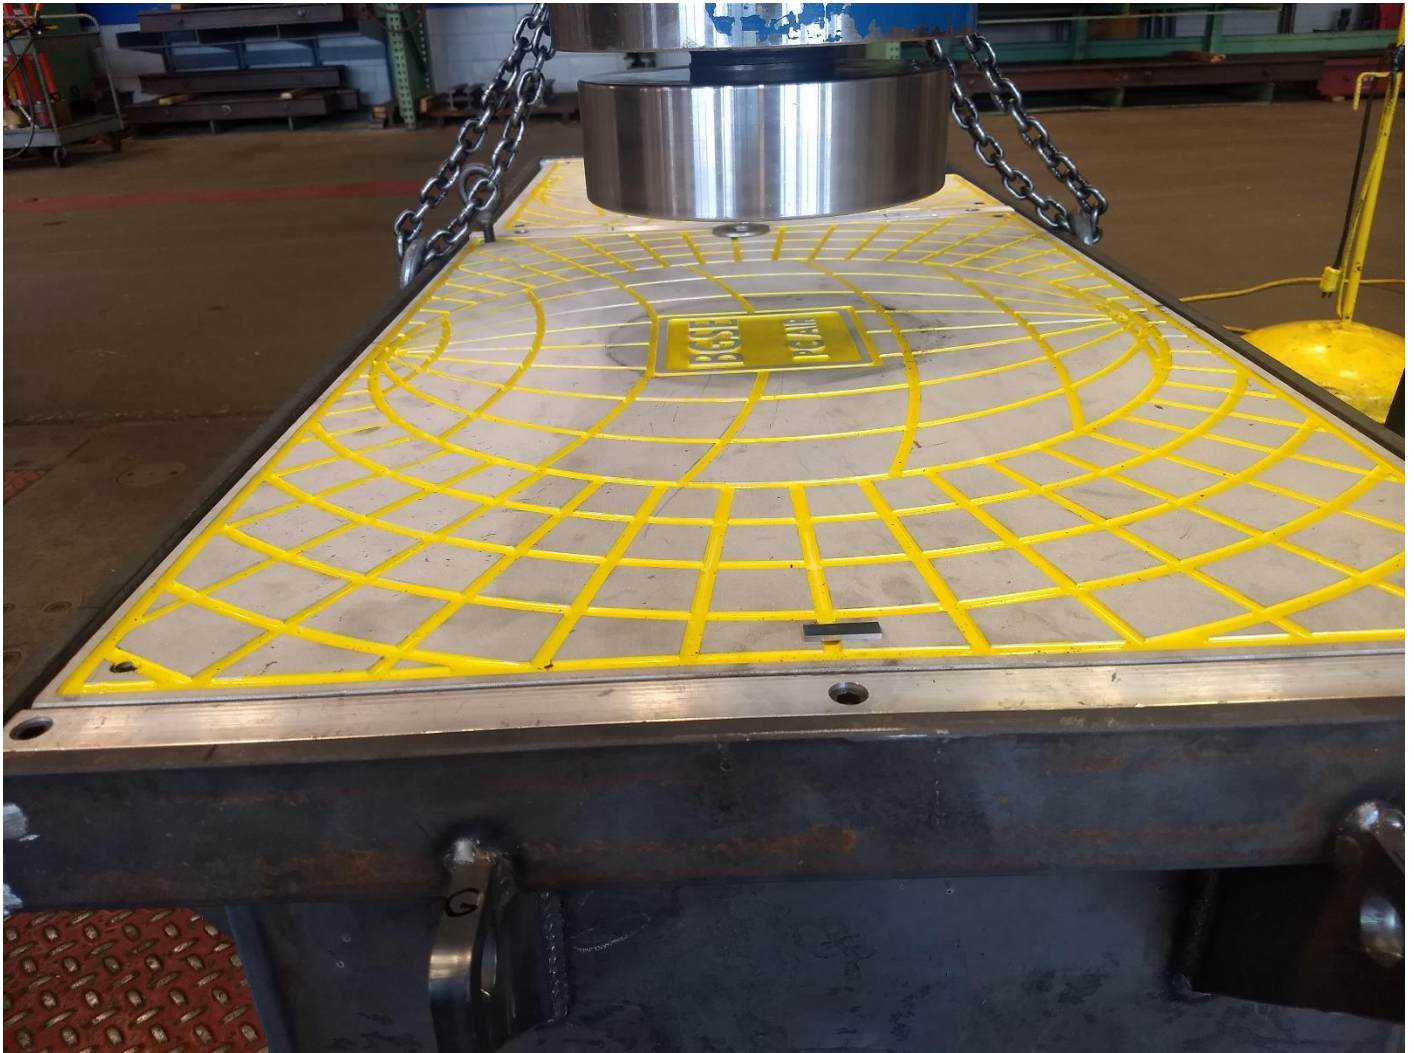
**Photograph 3 Cover and Frame Post Test**

8.3 The load bearing capacity test demonstrated the capability to hold a load of 900 kN. After the test there was no visible damage and no measurable permanent set. The condition of the cover after removal of the test load is shown in Photograph 3.
